HISTORIC STRUCTURE REPORT

TUMACACORI NATIONAL MONUMENT
Arizona

by
Anthony Crosby

September 1985

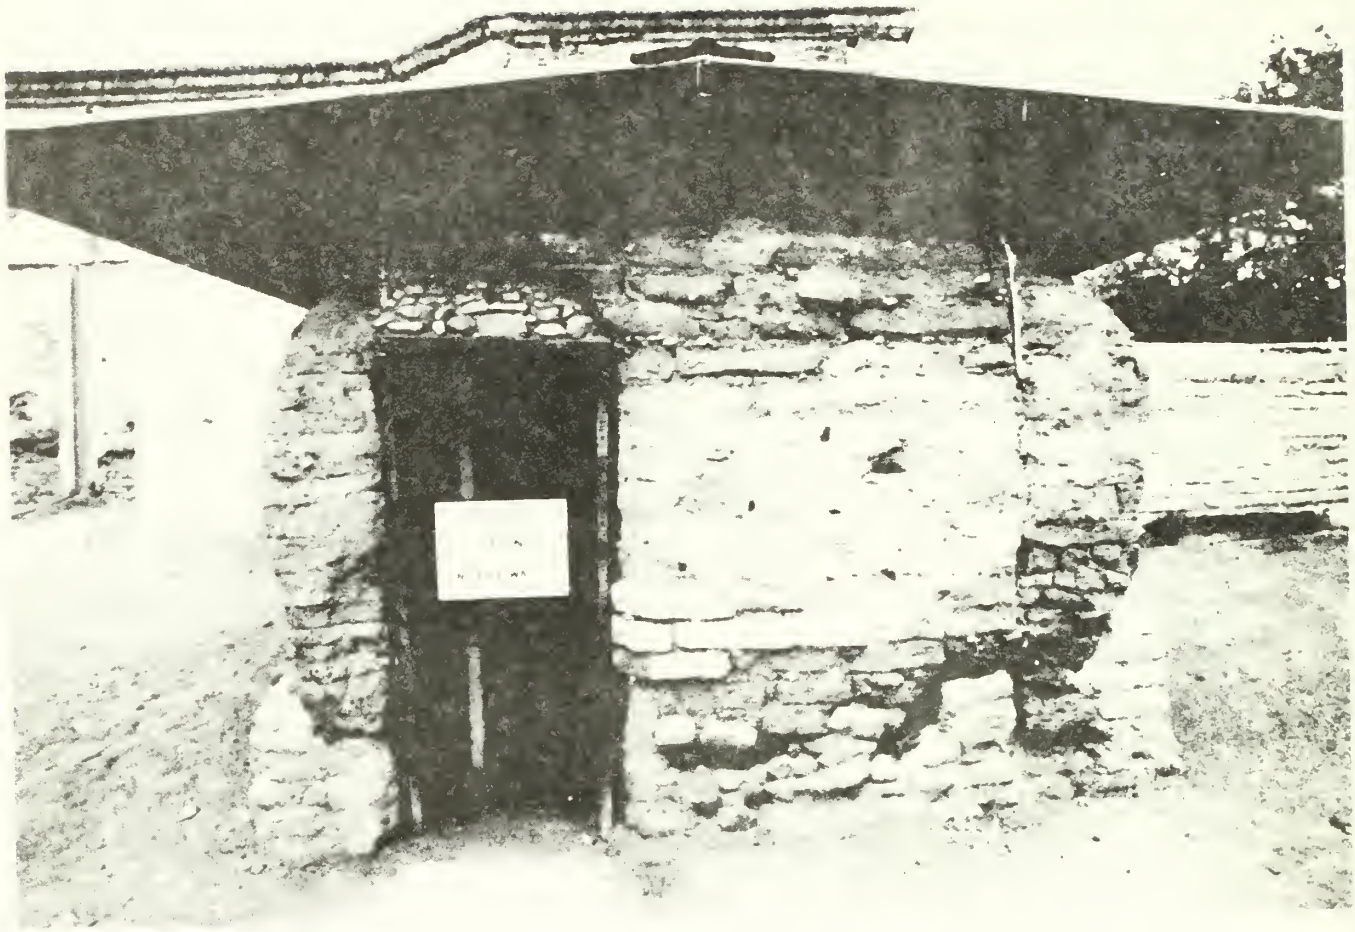
Deterioration from capillary moisture was initially and continues to be most prevalent at the northeast corner and the east wall. The conditions were

4. A view of the corridor prior to the removal of the protective roof. Photograph taken in August 1979.

so critical that repair was undertaken in the fall of 1977. The actual method was simply to fill the major void on the interior, or west side, with mud, fired brick and adobe batts, and rocks. The area was first cleaned of all loose friable material, the surface kept damp, and the fill brought up in successive layers in the deepest concave areas to facilitate drying. The mud, which had a content of approximately 15 percent of nonexpansive clay, was packed in so that it would have more capillary potential than the adobe wall. If properly executed, moisture which will continue to rise in the wall will move, if not be drawn, through the new fill material causing this new material to deteriorate rather than the old. Only the most critical area was repaired at that time, but a similar approach was carried out later on remaining areas.

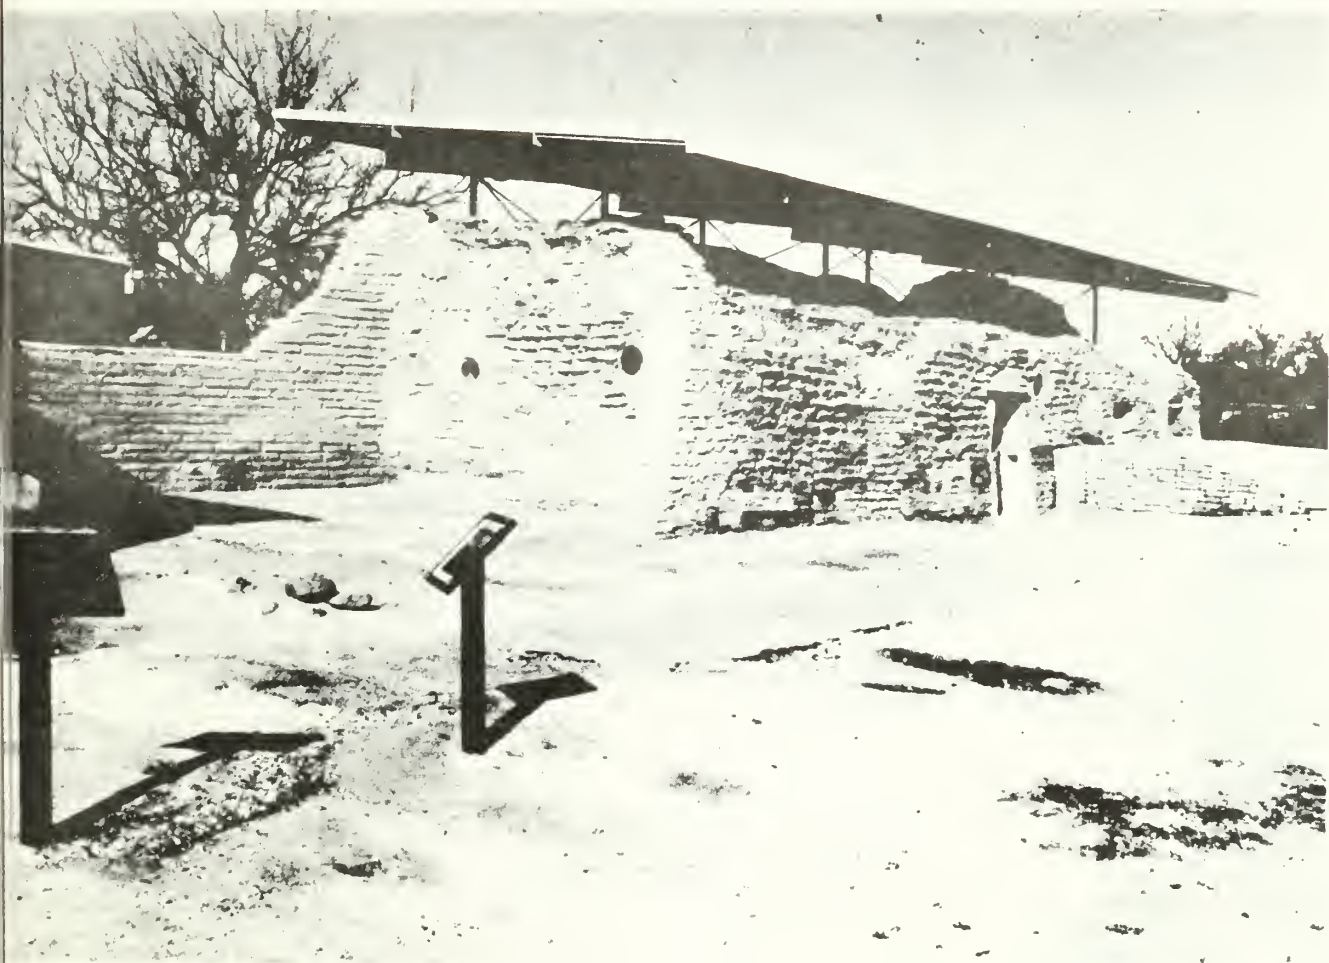
6. The granary from the southeast before the removal of the protective roof.

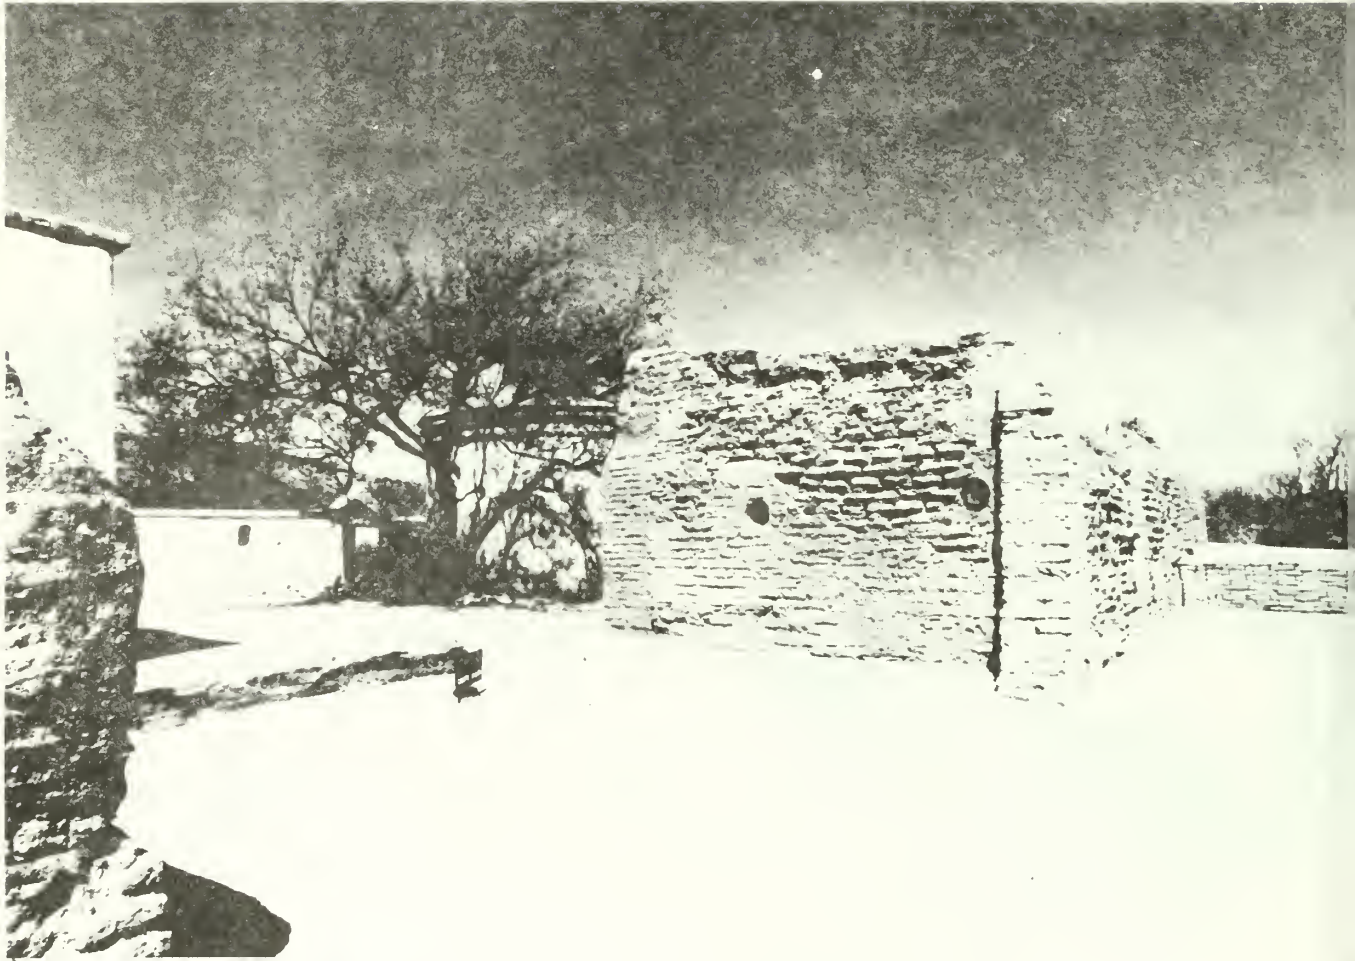
7. The granary from the southeast after the removal of the protective roof.

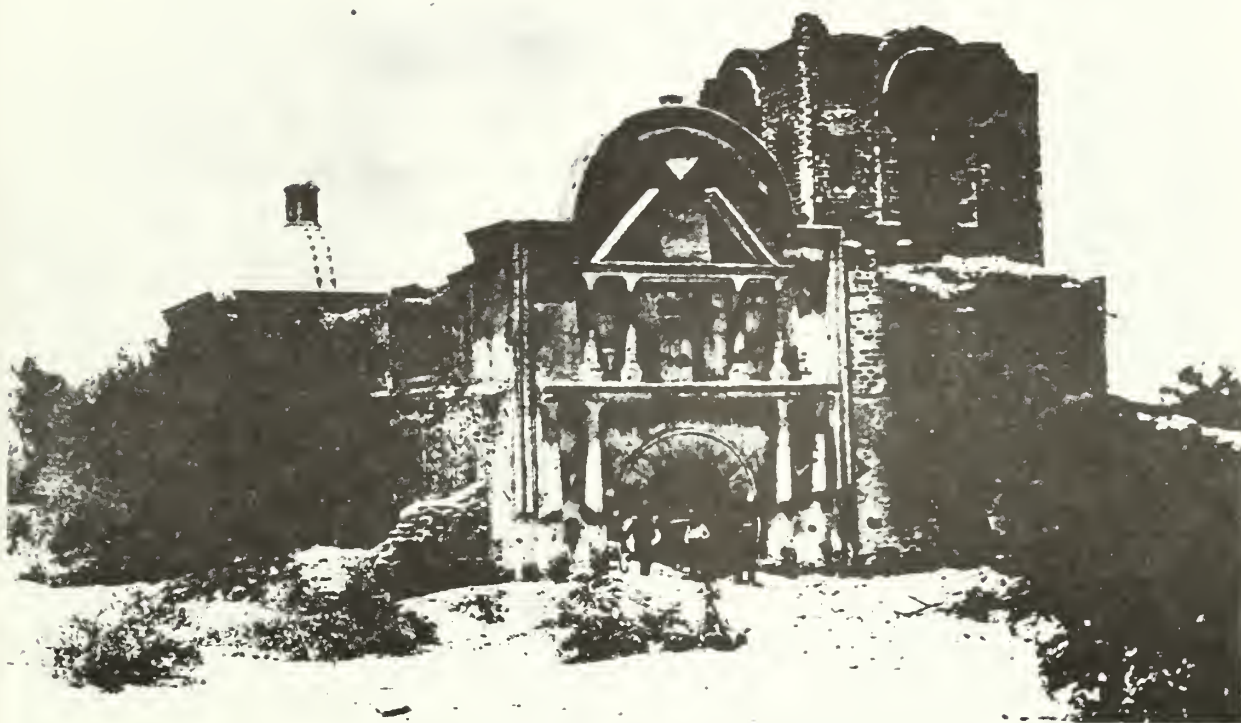
Early photographs of Tumacacori clearly indicated the absence of a roof over the nave. Later photographs show the effects of erosion on the upper portion of the walls (illustration 10). The upper wall erosion suggests that rainwater also percolated down through the walls to further weaken them. Basal erosion to a depth of 12 inches into the walls certainly compromised the structural integrity of the building even more.

10. An 1889 George Roskrige photograph of the church from the south.
Photograph is from the Tumacacori National Monument files.

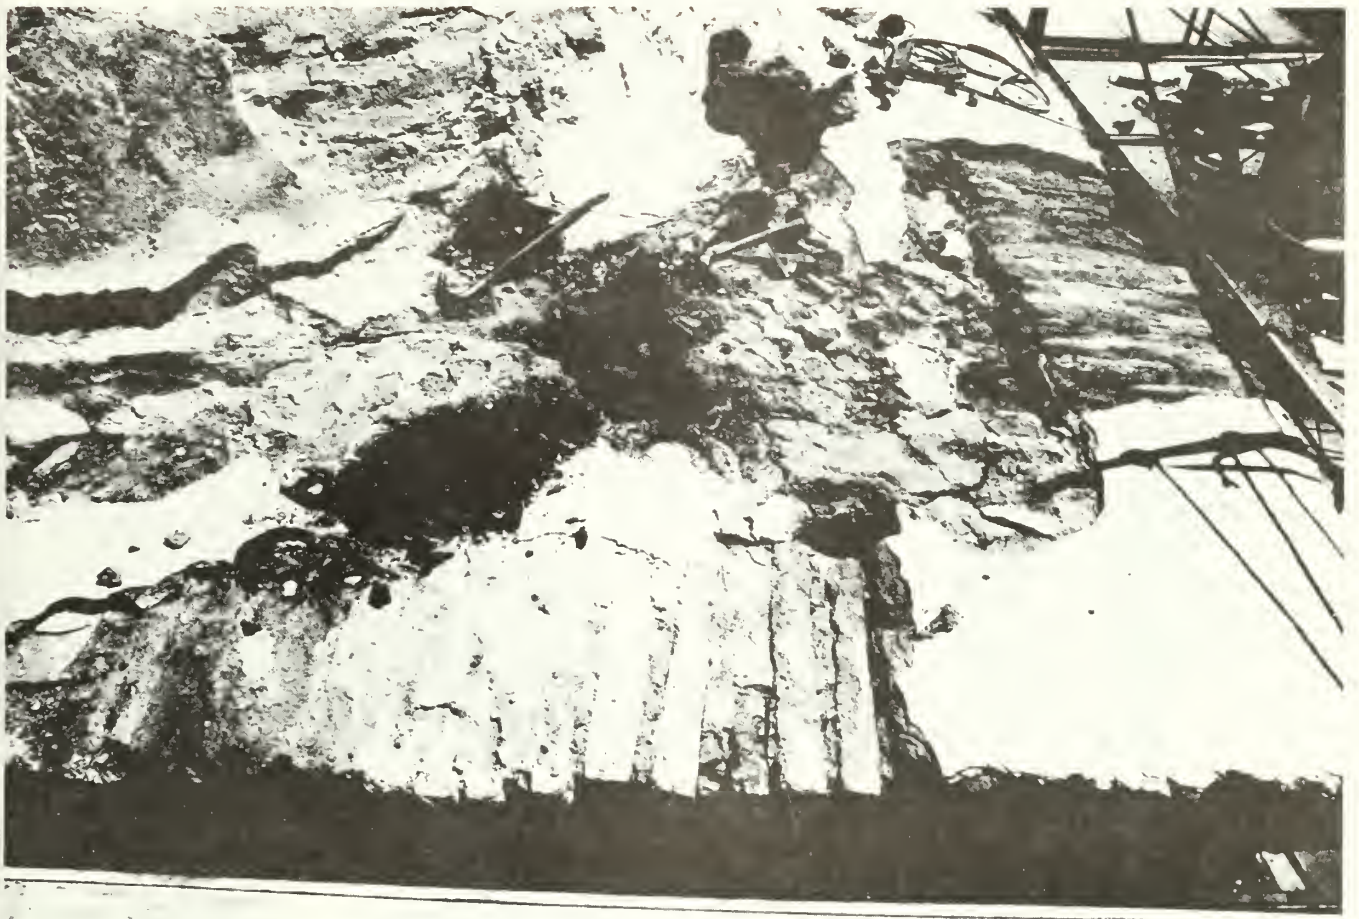
When the soil was removed, additional cracks in the masonry beneath the fill were found. Some of these cracks completely isolated the portion of the brick cornice on the northeast and northwest corners. The cause of these cracks was not determined. They could have occurred quite early, perhaps soon after construction. But it is also likely that at least some occurred because of excessive loading along the cornice caused by a combination of excessive moisture content and horizontal erosion of the adobe immediately below the cornice.

12. A view of the northwest flat portion of the sanctuary adjacent to the dome after removal of the cement stucco. Photograph taken in August 1979.

Because of the precarious nature of the two corners, the cornice bricks themselves were tied to the adjacent secure portion of the cornice. This was done by installing a No. 4 re-bar in epoxy resin grout into a groove which was cut into and followed the cornice line. The groove was cut approximately 2 inches deep to secure the bar with an adequate amount of epoxy. The other cracks were filled with lime grout to the extent possible, and the space previously filled with soil was filled with fired adobe bricks in dry mortar. The entire area was then covered with brick pavers and two coats of lime plaster.

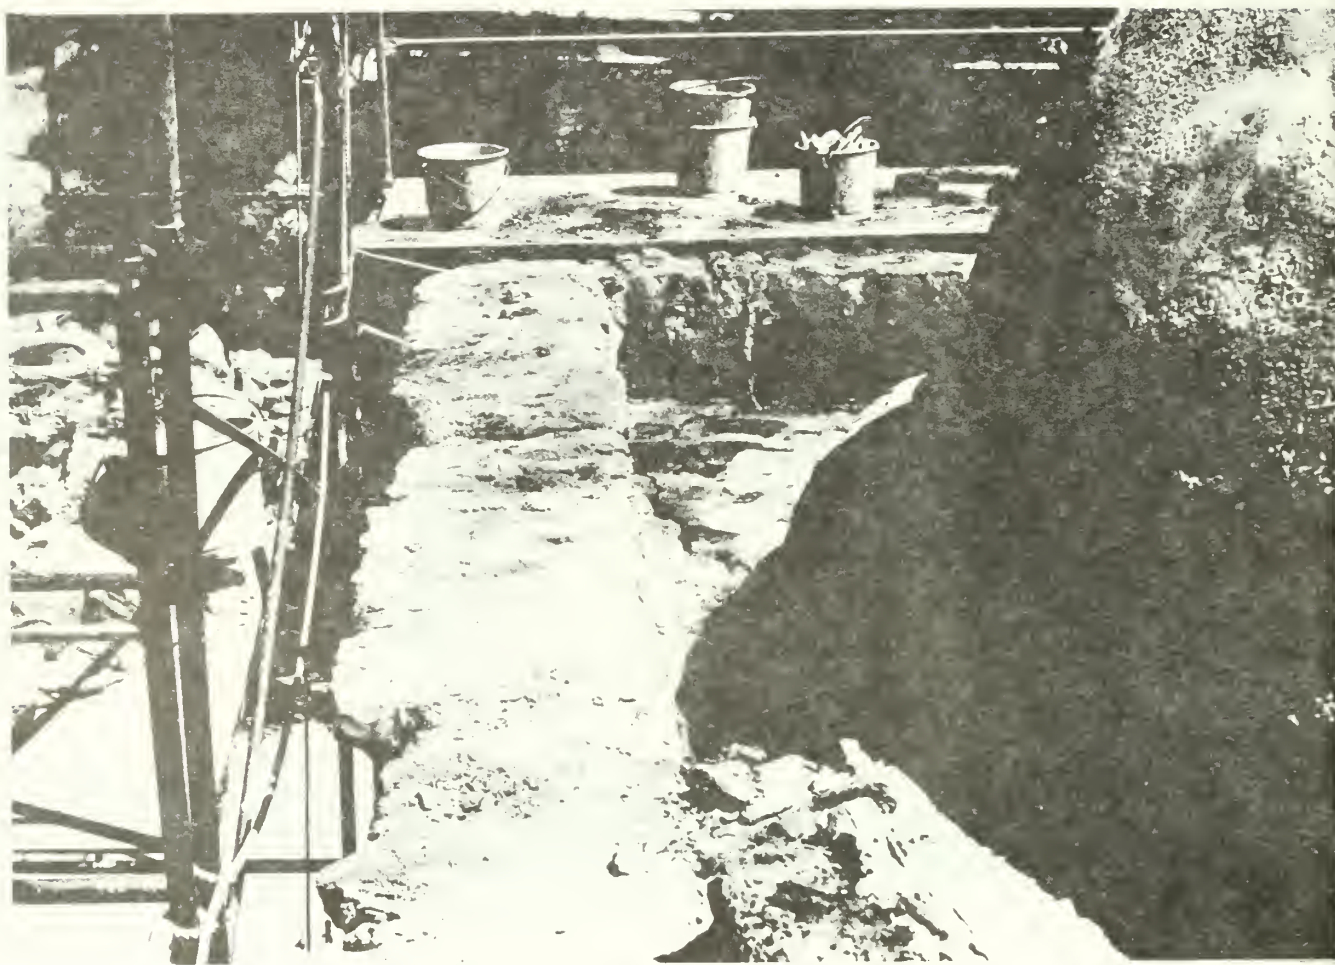
13. A view of the west side of the dome and top of the sanctuary from the south after the removal of the dirt fill.

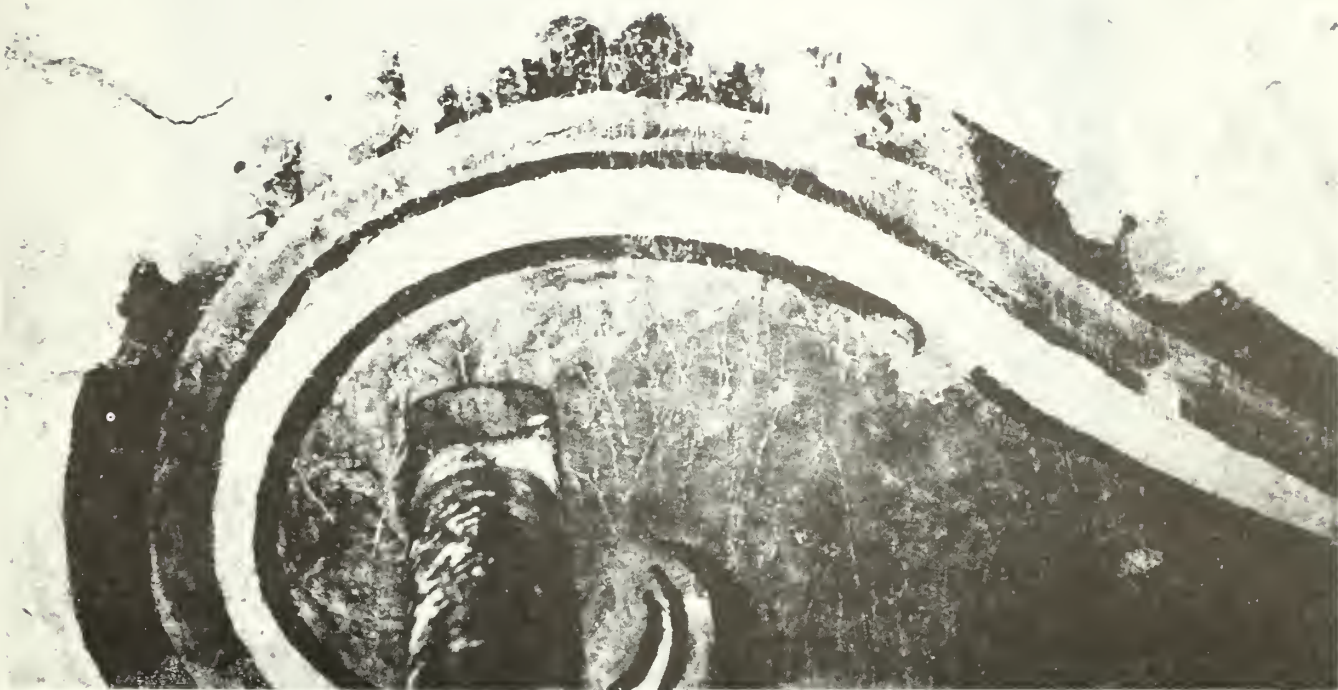
19. Painted volute on the sanctuary's north wall after treatment, August 1982.

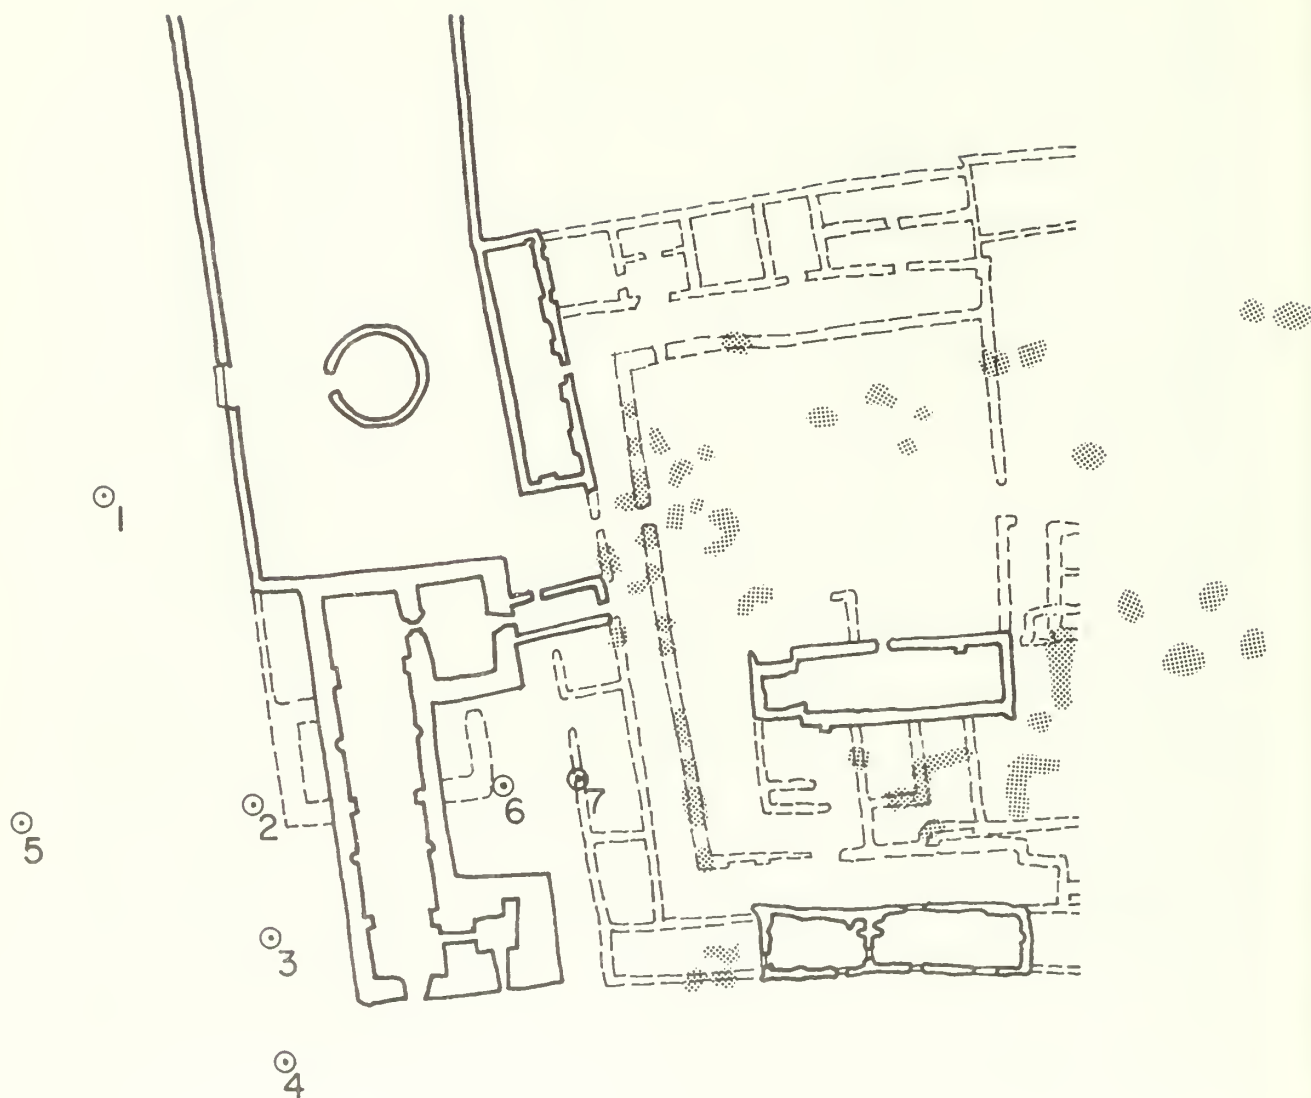
SOIL MOISTURE MAP

At the time of the subsurface investigation, Doug McCollough, chief of maintenance at Tumacacori, pointed out several spots in the area of the convento patio that appeared to be wet (illustration 22). A continuous monitoring of these spots indicated they remained dark, or stained, and at relatively high moisture contents throughout the year. On May 26, 1977, after a period of two months without rain, the moisture content by weight of the soil only 1 inch below the ground surface in two of these dark spots was 8.6 percent and 6.2 percent. A nonstained area used as a control contained 1.5 percent moisture.

The darkest areas were approximately 40 feet east of the east nave wall of the church, just to the west of the paved walk, southeast of the granary, and just east of the concrete block foundations that mark the apparent foundations of an earlier Jesuit church. The architectonic quality of these stained spots seems to indicate some direct relationship to subsurface architectural remains. The one area that extends parallel to

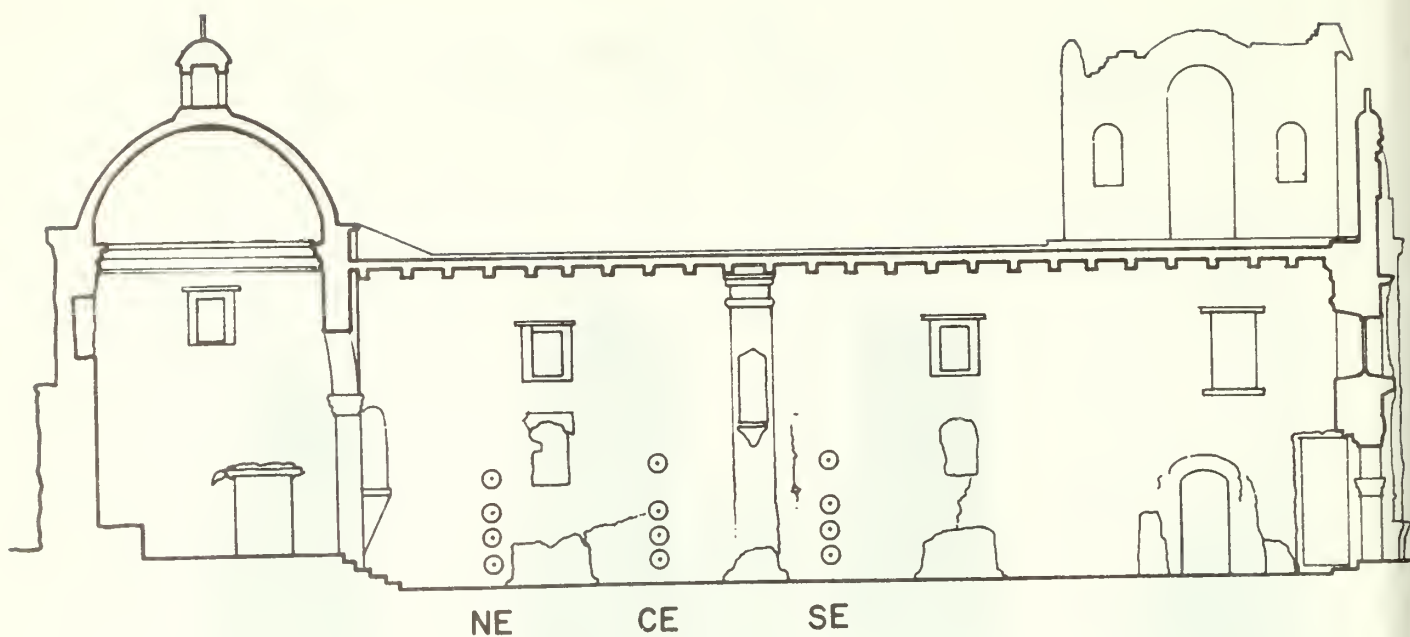
ILLUSTRATION 25.

Profiles based on the actual moisture contents of the seven different locations are shown in illustrations 25 and 26. The profiles at locations SE, CE, and NE are classic capillary moisture profiles with little abnormal moisture occurring higher than 4 feet above the exterior grade.

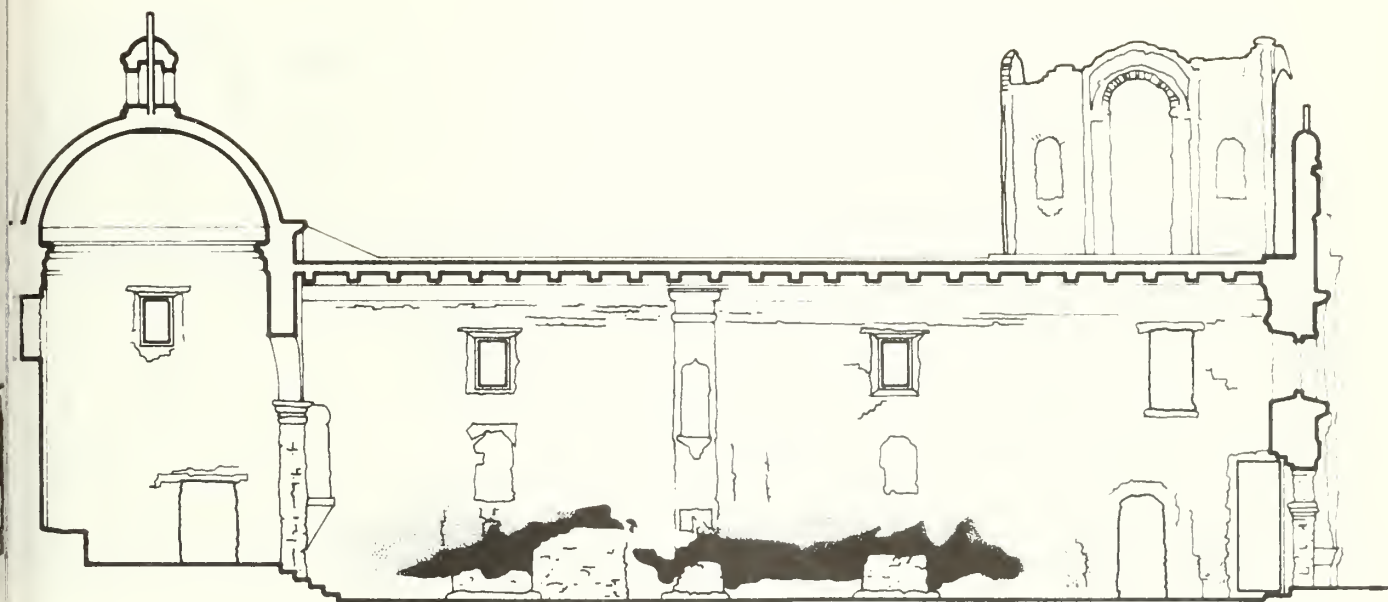
ILLUSTRATION 29.

A surface survey conducted in April 1977 (illustration 29) indicated a relative decrease in surface moisture which, again, probably related directly to the absence of significant rainfall during the period since January. However, a survey conducted on May 14 of that same year showed an apparent increase in surface moisture although there had been no rainfall at all for six weeks (illustration 30). This increase did not relate to any known cause in the cause-effect relationship except an increase in the relative humidity from May 4 to May 10. It is highly unlikely that the increase in ambient moisture would have a continuing effect on the actual surface moisture content several days later.

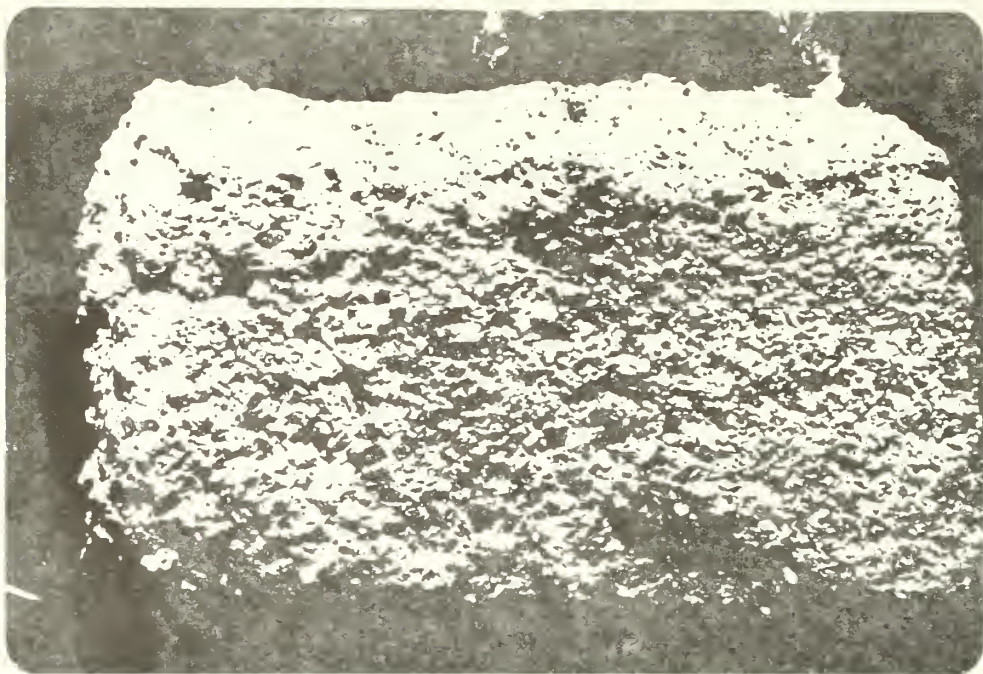
Figure 1a: Rear or unfinished side of Sample B after the drying associated with test 3. Three-treatment area is on the upper right and the one-treatment area is below it. Scale: approximately actual size.

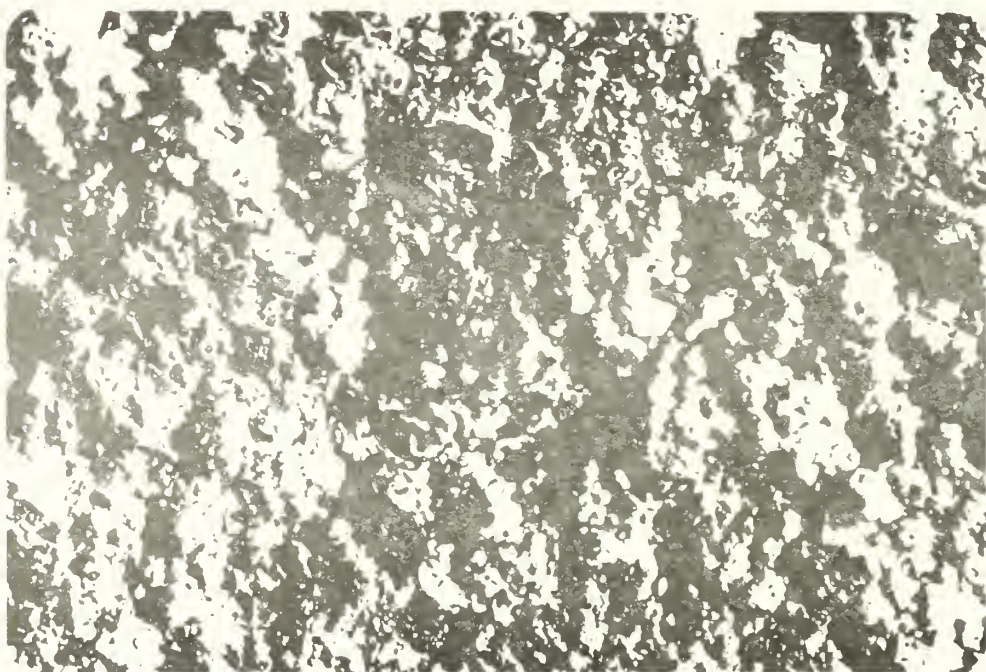
Figure 1b: Detail of Figure 1a showing heavy efflorescence. Scale: approximately three times actual size.

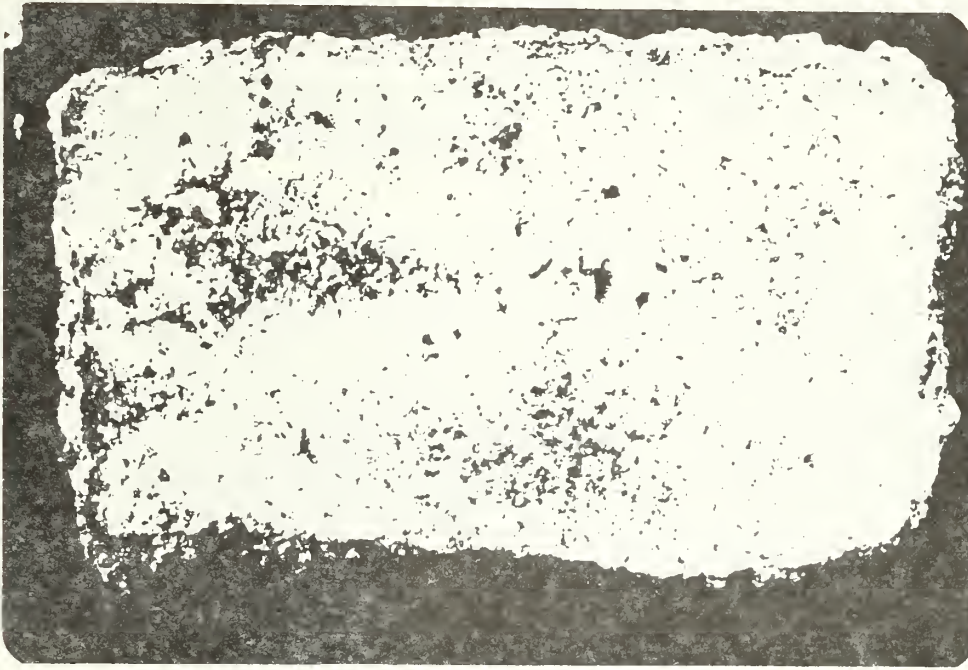
Tests 5 and 6 were conducted using room temperature tap water again. Figure 2 is a photograph of the front or finished side of plaster after drying associated with test 5. There is certainly some variation in the amount and distribution of the efflorescence, but there appears to be little difference in the one-treatment and three-treatment areas. In addition, visible surface decay began to occur. This decay is in the form of more friable raw plaster edges, fractures near the plaster perimeter, Figure 3, a more rough surface texture, and a general powdering

Figure 2: Front or finished side of plaster Sample B showing efflorescence which formed in associated with test 5 drying. Treatment areas are at the upper and lower right. Scale: actual size.

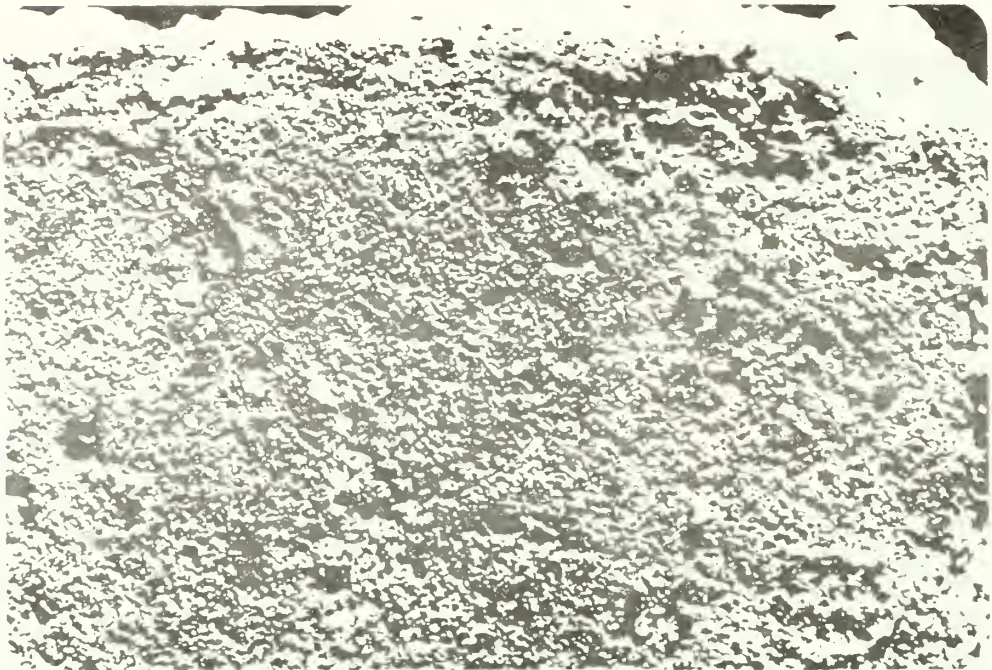
of the surface. The powdering and increased roughness of the surface results as individual sand particles are isolated as the calcium carbonate binder erodes away, and as small sections of the surface is pushed up from the original surface plane. The erosion of the calcium carbonate binder can be seen in the photographs of Figures 4a and 4b. Examples of the surface being lifted are pointed out in Figure 5 and in the sketch below.

Figure 4b: Detail of Figure 4a. Scale: approximately two
times actual size.

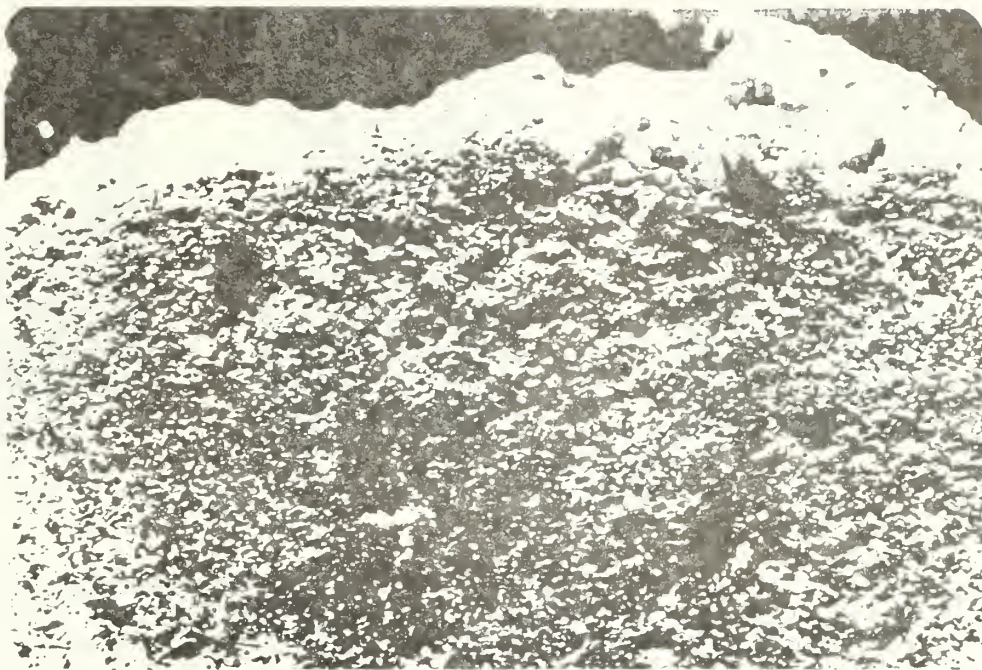
In this latter case, the salt crystals, lifted the surface material, then recemented it in place. However, when the salts went back into solution as the material was rewetted, the separated area would come off under minimal pressure.

Figure 5: Detail of the upper right of plaster Sample B where small sections have lifted from the finished surface. Scale: approximately four times actual size.

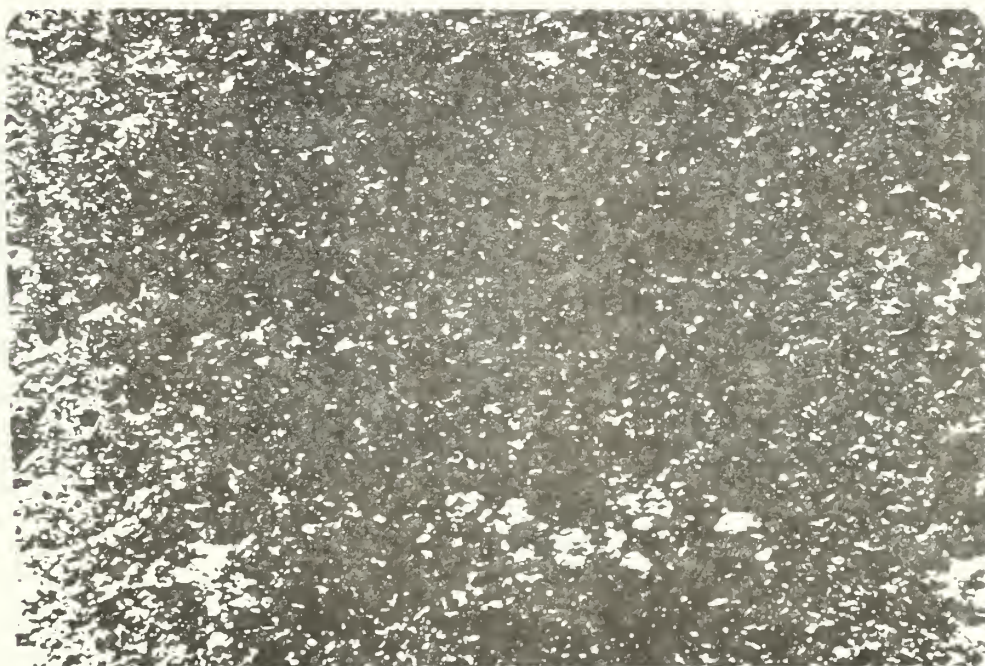
After test 3, the Acryloid B-72 was clearly visible on the surface. After test 4 the B-72 appears to have been pushed from the surface, was somewhat fuzzy, and some had disappeared. It remained clearly visible after the subsequent tests in the three-treatment area. One of these is pointed out in the detailed photograph of Figure 6.

Figure 6: Detail of the center right portion of plaster Sample B showing the remains of some Mervoid B-72 which remained on the surface. Scale: approximately four times actual size.
